Bradford County Flooding

Lake Sampson Drainage

Problem 3 Trail Ridge South Mine

Trail Ridge South Release Incident NO. 20024-0997 5 day Report

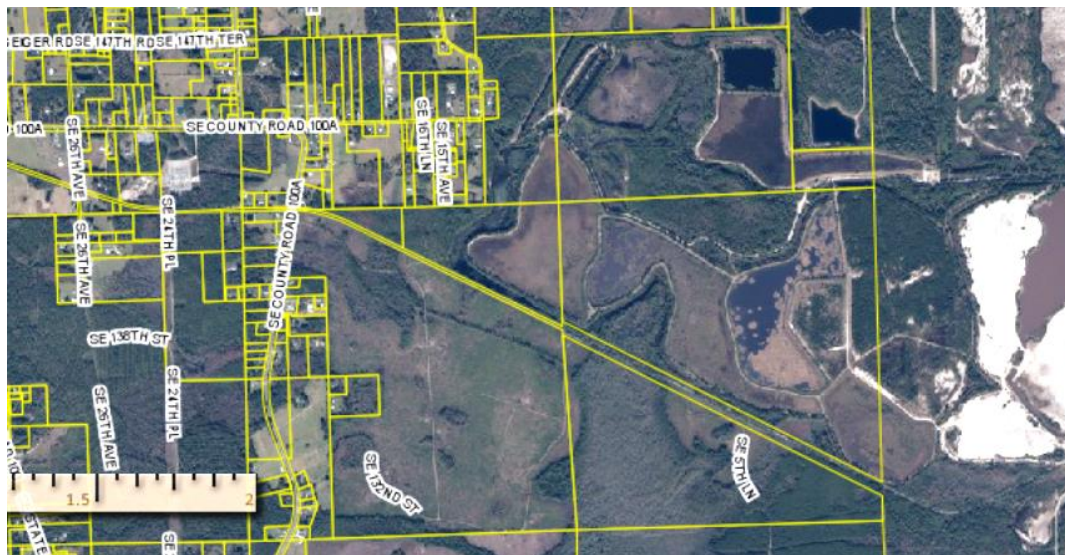
The Chemours Industrial Wastewater treatment system includes a series of raised settling ponds in Bradford County east of Starke shown in the image on the next page.

Failure of the structure along the western side of the ponds that holds the water in the ponds could create significant flood risk for homes just west of the holding ponds.

During Irma in 2017 Chemours discharged Industrial Wastewater at rates higher than is permitted by its Industrial Wastewater Permit. These excess discharges could have contributed to flooding of homes and apartments along Alligator Creek upstream of 301.

Water flow from the Chemours operations over the rail line (double yellow lines in the above image) onto the triangular shaped parcel south of the Chemours holding ponds owned by the North Florida Land Trust has been evaluated. During major rain events water flows over the railroad tracks flows west and then flows north back under the Bradford Apartment complex that was flooded during Irma. The discharges over the railroad tracts would not have been included in the reported Industrial Wastewater discharge reports.

Seek assurance from DEP that the Chemours holding pond system has sufficient capacity to hold stormwater and process water from a significant rain event.

Request DEP not allow the discharges over and under the rail road tracts south of the Chemours ponds.

Request Chemours inform Emergency Management whenever its discharge rate exceeds 20 mgd.

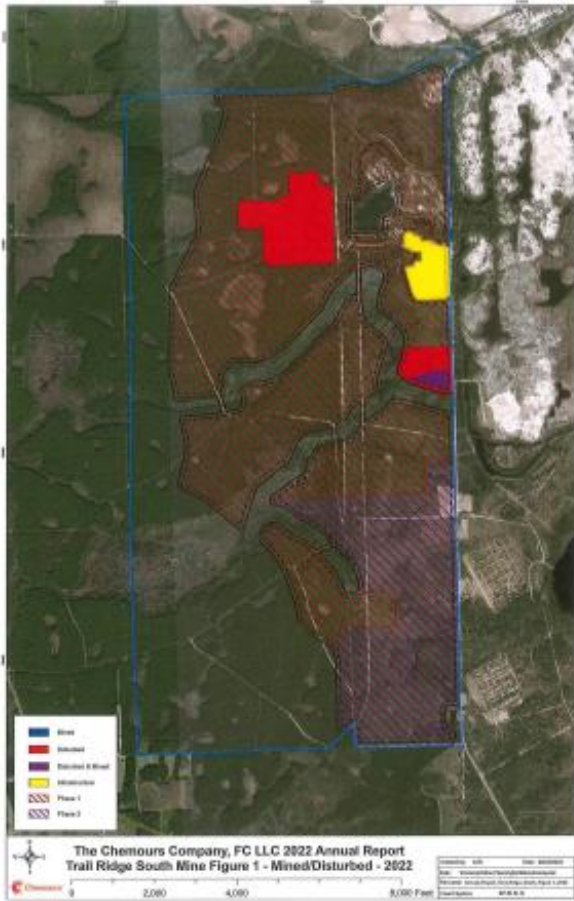
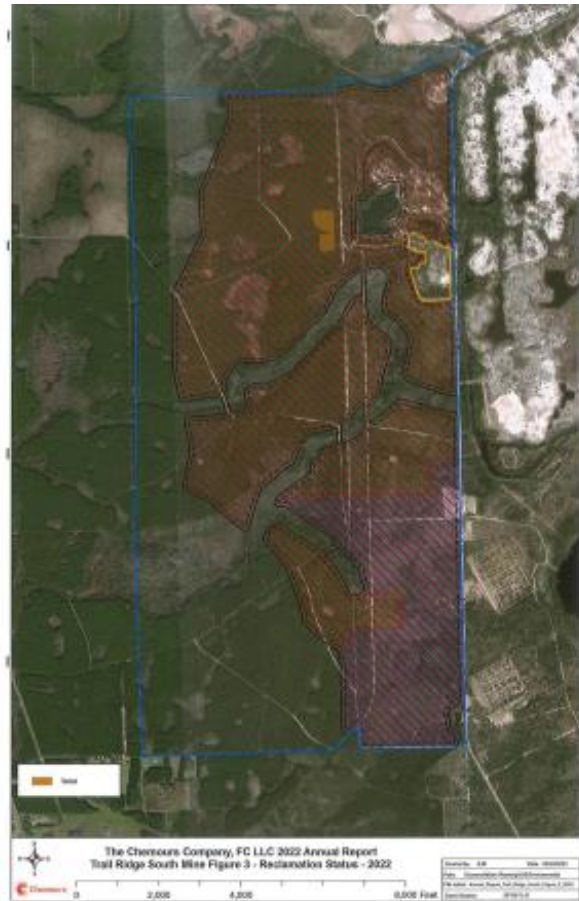
Should the pre-dig pit area be shown as mined?

Should the pre-dig pit area in tan in the image on the right be shown as mined in the image on the left?

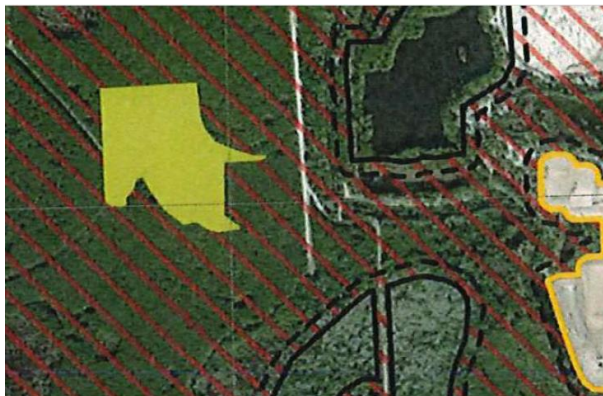
Figure 3 Reclamation Status 2023

Why was the expanded tailed area in Figure 3 adjacent to the 2022 pre-dig pit not referenced in Section e?

If there was a pit associated with the 2023 tailed area, how deep was the pit?

What is the area of the 2023 tailed area?

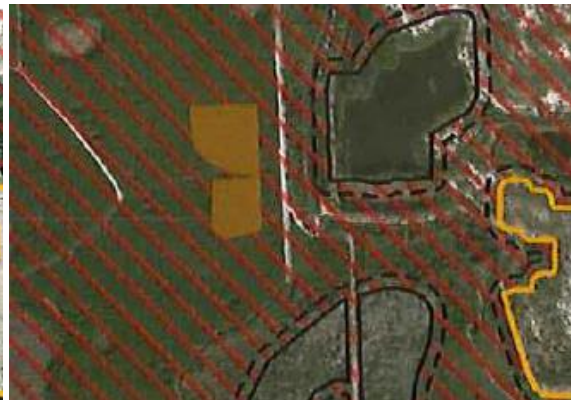
Figure 3 Reclamation Status 2022

Why is the Tailed area in the 2022 Annual Report not shown in the 2023 Annual report?

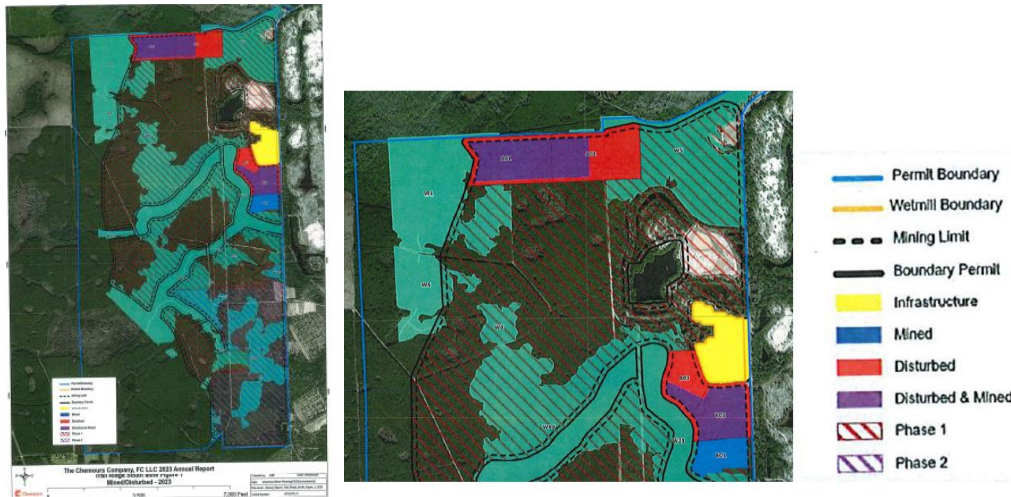
2023 Annual Report Attachments Figure 1

What is the difference between Permit Boundary, Boundary Permit, and Mining Limit?

What is the difference between Mined and Disturbed & Mined?

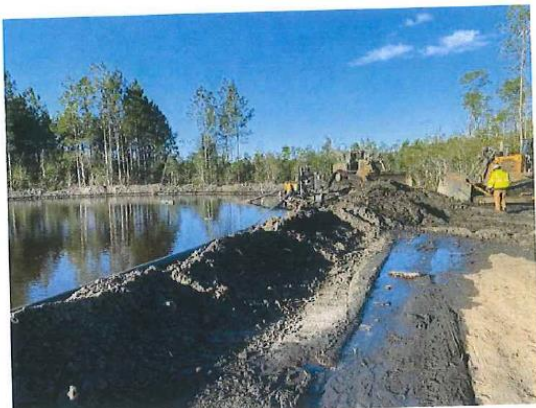
Northwest corner Reclamation cell
(January 31, 2024)

Is the berm shown in the image below the berm referenced by the words “Operators immediately constructed a berm” or is it the berm referenced by the words “A portion of the reclamation cell remains bermed”?

What was and is the depth of the water contained by the berm in the following image?

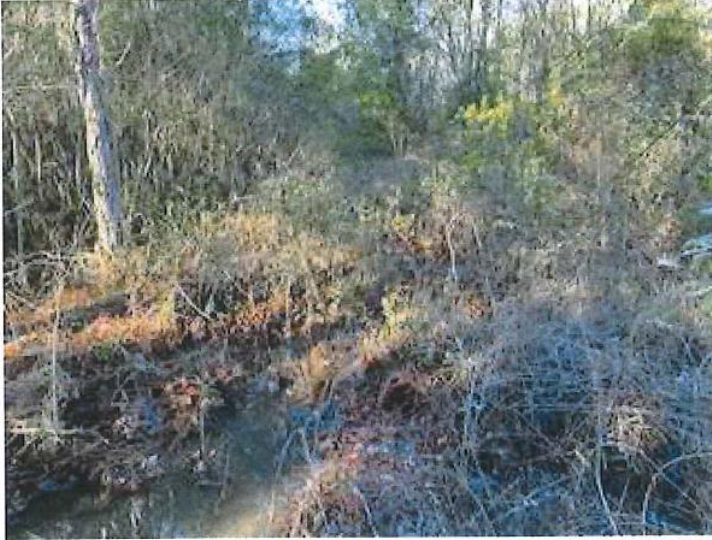
Firebreak
(January 31, 2024)

What is the grey material seen under the water in the above image?

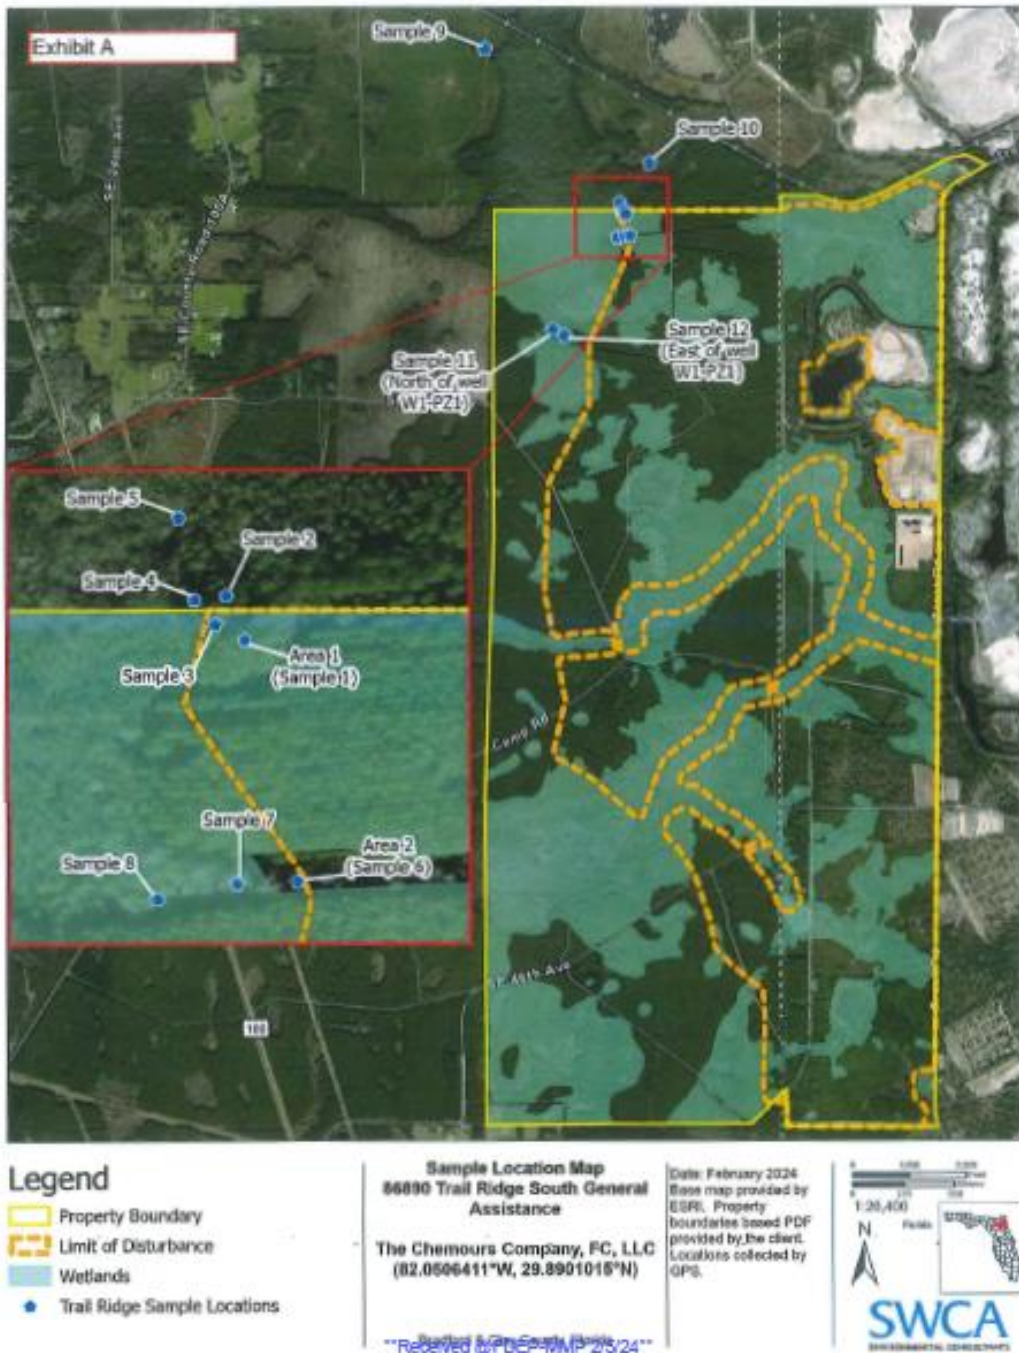
Are Sample 2 and Sample 4 on NFLT property?

Why is the location of the berm breach not shown on the image?

Why is the location of the berm overtopping not shown on the image?

Where is the mine cell pit that was receiving the process pond water?

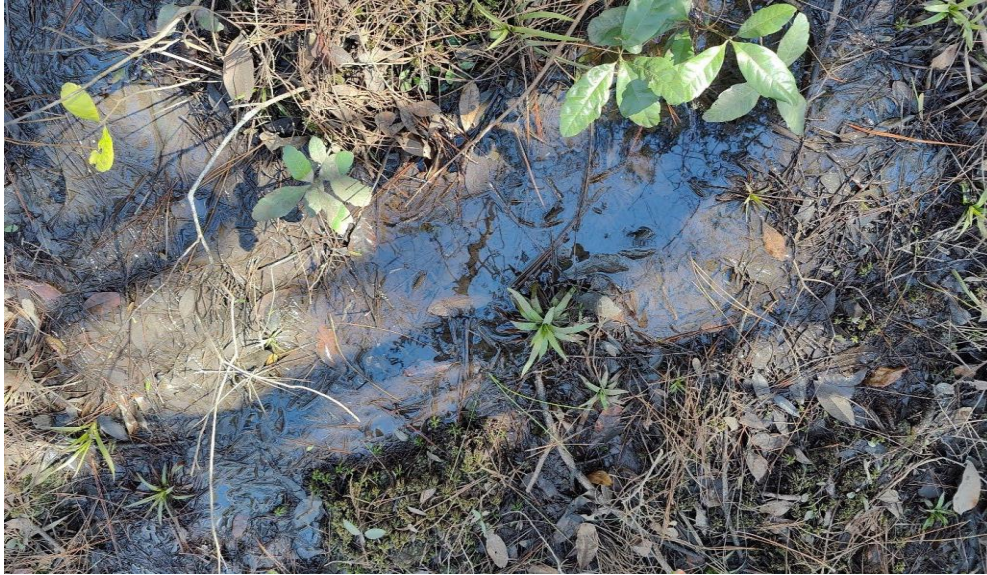
Inundation in Area 1.

Is the light grey material on soil surface and leaves in top image on page 3 from the Inspection Report copied on the next page sediment deposition?

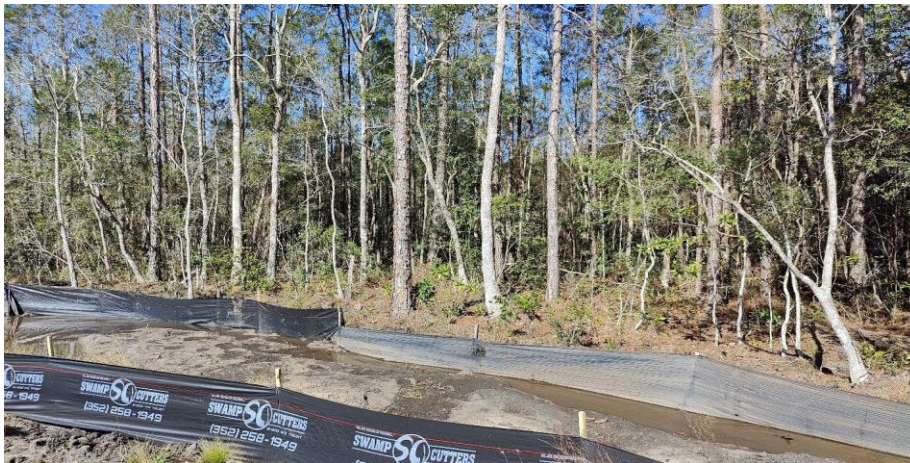
Area 1, showing double row of silt fence containing standing water.

Is the light grey material silt fence in the above image in the Inspection Report from sediment deposition?

Did the force of released water push the original silt fence down?

Why was the integrity of the silt fence not referenced in the Inspection Report?
