Draft of a letter to be sent to DEP, EPA, SRWMD, and Bradford County

Based on the information in the documents we found in OCULUS, the Bradford Soil and Water Conservation District (BSWCD) has several concerns about the operation of the Chemours Trail Ridge South (TRS) Mine on Suwannee River Water Management District (SRWMD) property in Bradford County. The BSWCD believes that answers to the questions ask in this document will reduce the chances of environmental impacts from the operation of the Chemours TRS Mine in the future. The documents being referenced are in bold type.

## Trail Ridge South Release Incident NO. 20024-0997 5 day Report

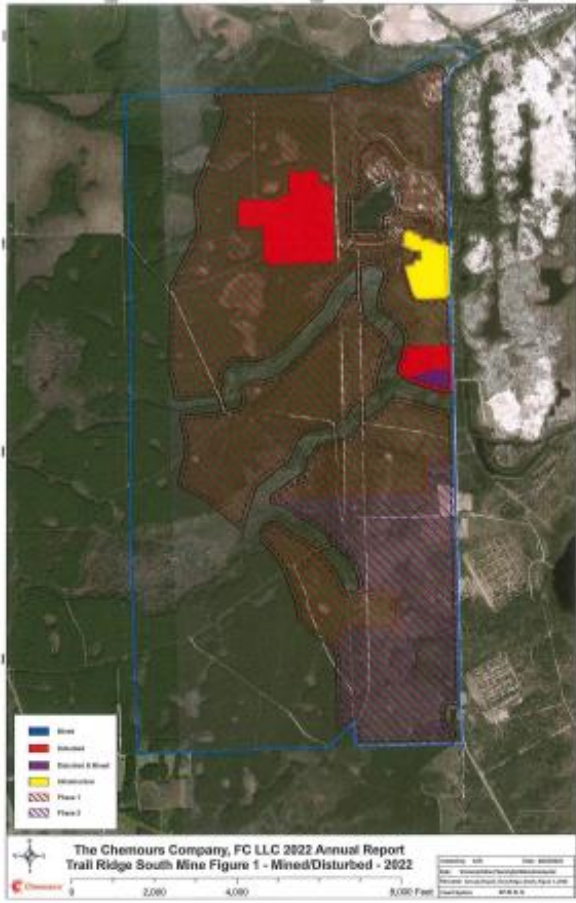
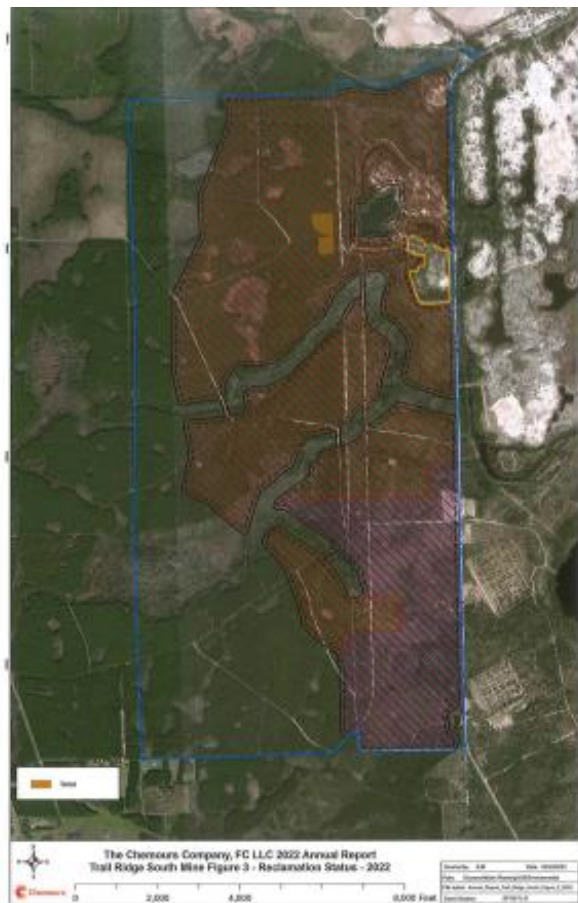
Should the pre-dig pit area in tan in the image on the right be shown as mined in the image on the left?

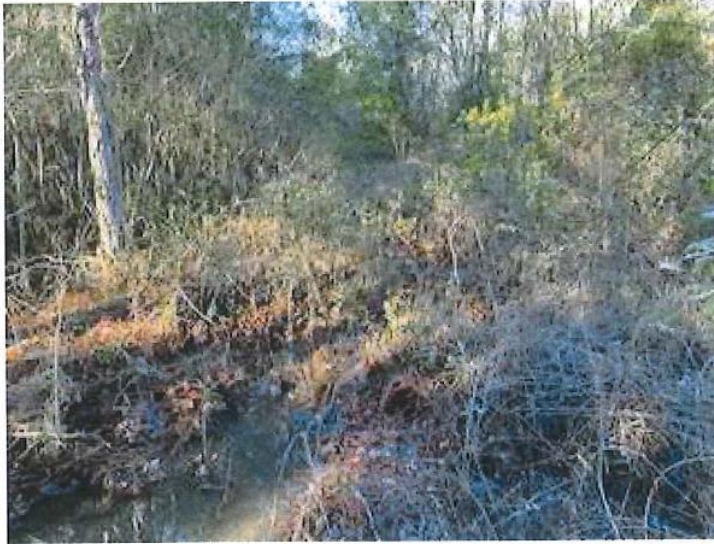
Firebreak  
(January 31, 2024)

What is the grey material seen under the water in the image from page 8 of the **Trail Ridge South Release Incident NO. 20024-0997 5 day Report**

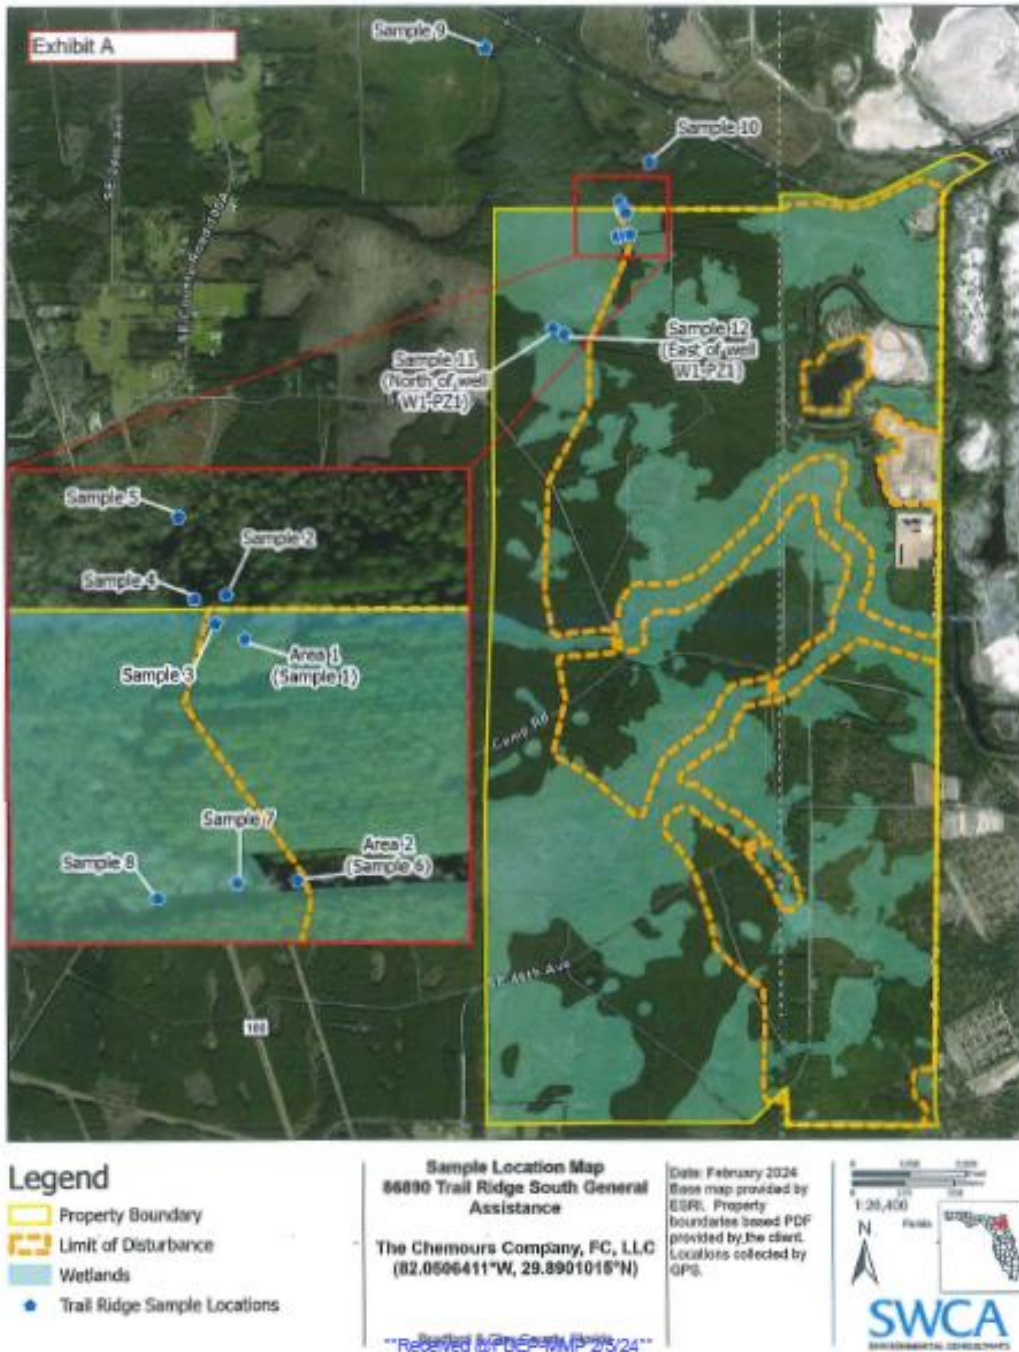
Are Sample 2 and Sample 4 on NFLT property?

Why is the location of the berm breach not shown on the image?

Why is the location of the berm overtopping not shown on the image?  
Where is the mine cell pit that was receiving the process pond water?  
Did the process water contain tailings?  
What was the concentration of the tailings in the process pond water?

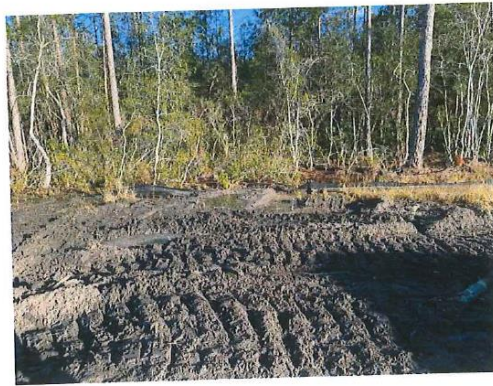
Northwest Corner Reclamation cell – Where water entered wetland  
(January 31, 2024)

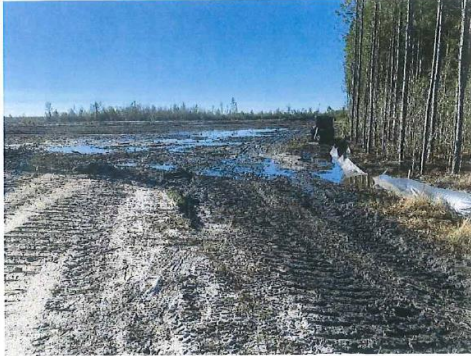
Area 2  
Water on Topsoil return area (January 31, 2024)

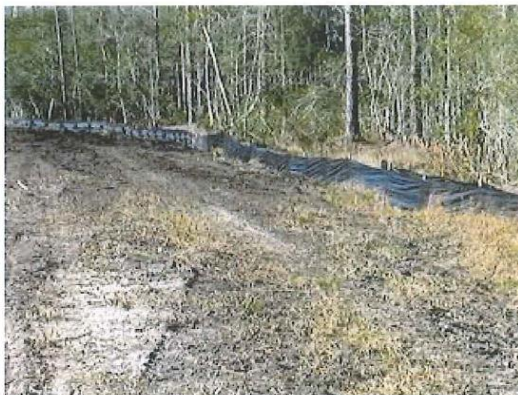
Silt Fence Repaired (January 31, 2024)

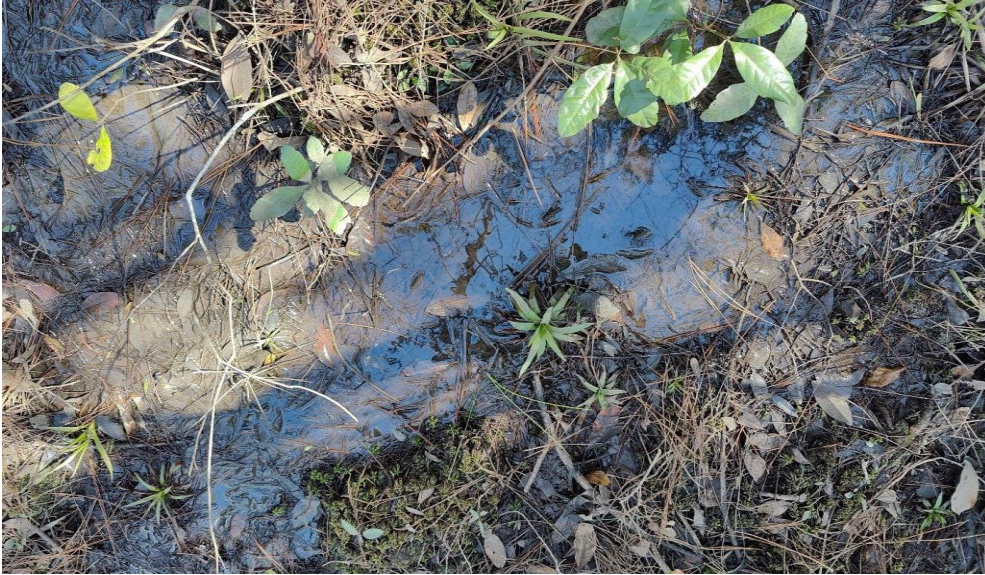
Is the light grey material on soil surface and leaves in top image on page 3 from the Inspection Report copied on the next page sediment deposition?

Inundation in Area 1.

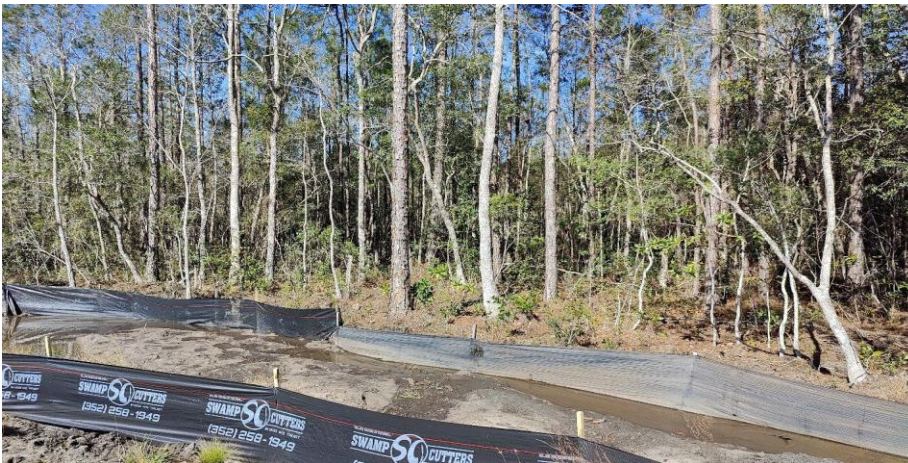
Area 1, showing double row of silt fence containing standing water.

Is the light grey material silt fence in the above image from the Inspection Report from sediment deposition?

Did the force of released water push the original silt fence down?
