The following images from 4/14/2024 and 4/16/2024 illustrate the BSWCD's concerns about the SRWMD's failure to address the issue of trash and debris on the Edwards Bottomlands Project.

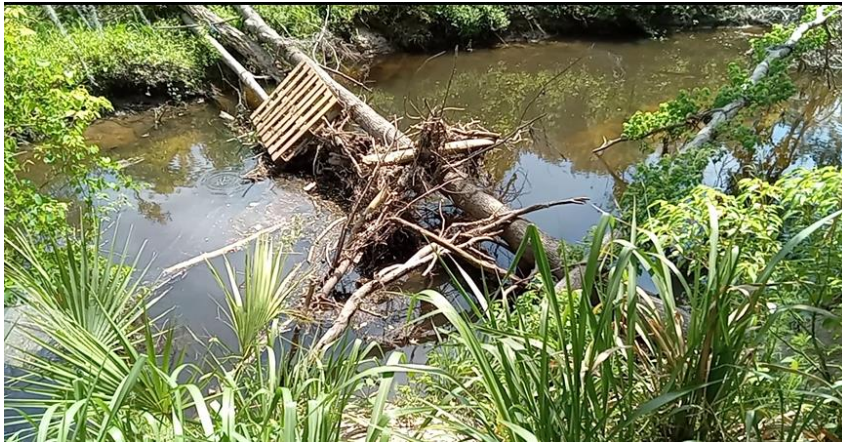
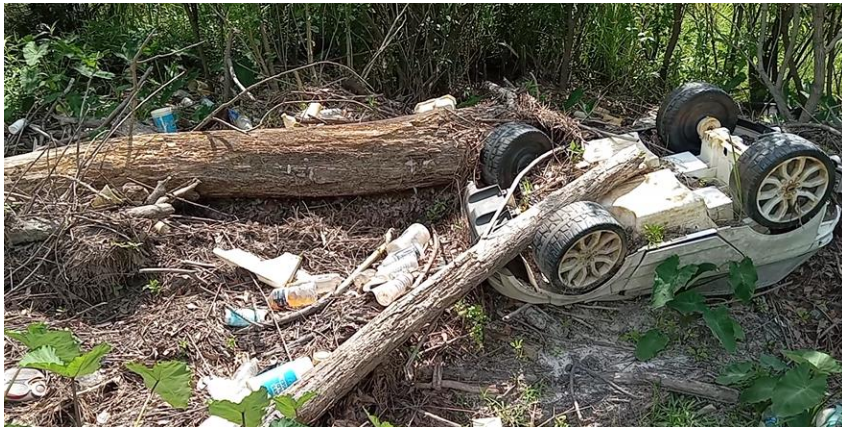
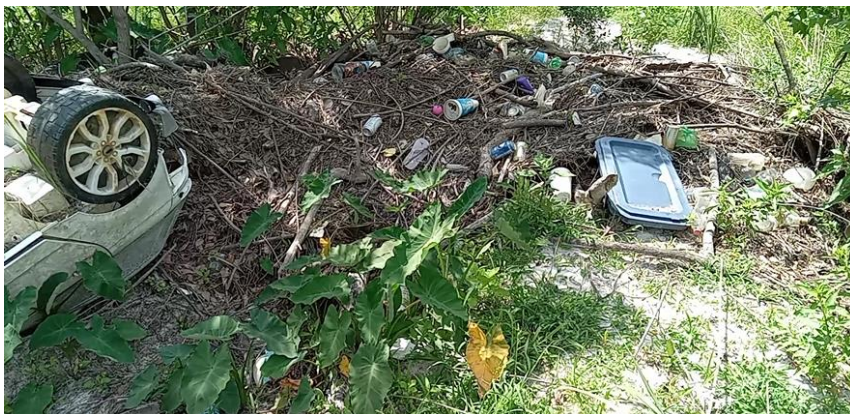
North side of Alligator Creek 4/16/2024

The trapped trash and debris slow flows in the secondary channel which can produce higher up stream peak water levels.
