Bradford County Flooding

Lake Sampson Drainage

Problem 3 Trail Ridge South Mine

Trail Ridge South Release Incident NO. 20024-0997 5 day Report

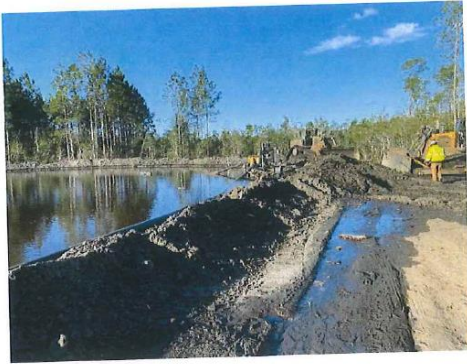
Northwest corner Reclamation cell
(January 31, 2024)

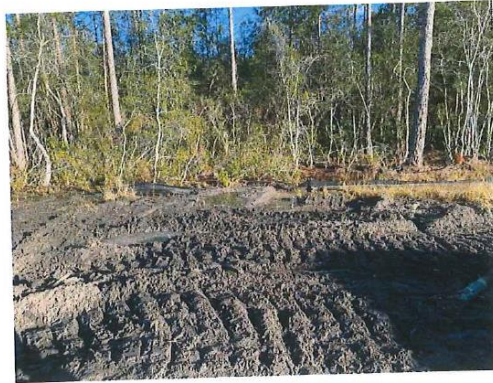
constructed a berm to contain the water remaining in the remaining berm. Supervision was notified and the operations were shut down. Review of the area for source of water indicated a "washout" by the active tailings line which caused water to flow back toward the reclamation cell. From the topsoiled area, water left the site at an historic fire break and water from the northwest corner of the reclamation cell entered the adjacent offsite wetland. The water did not contain humate and there was not any breach of the reclamation cell structure. There was no deposition of sediment in the wetland.

Northwest Corner Reclamation cell – Where water entered wetland
(January 31, 2024)

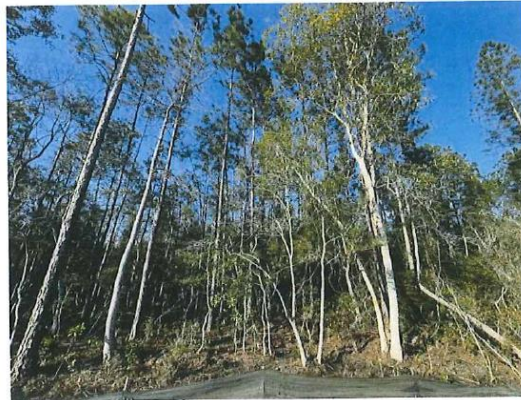
Northwest corner Reclamation Cell
Representation of wetland (February 1, 2024)

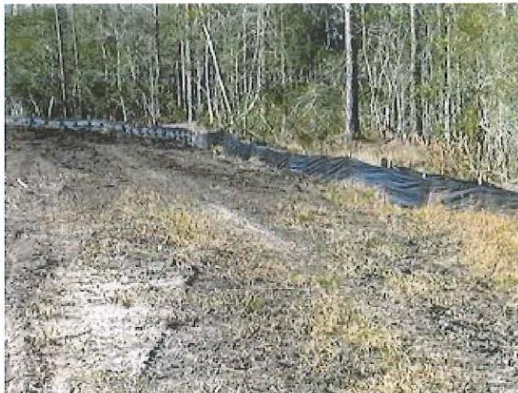
Silt Fence Repaired (January 31, 2024)

- Supervision and Environmental notified
- Rain pump in cell started to reduce water levels
- Environmental Assessment of release area
- Silt fence repair
